ACCIDENT

Aircraft Type and Registration:	Airwave Sport 3-L paraglider, no registration required	
No & Type of Engines:	None	
Year of Manufacture:	2006	
Date & Time (UTC):	7 September 2006 at about 1830 hrs	
Location:	White Rocks, near Portrush, County Antrim	
Type of Flight:	Private	
Persons on Board:	Crew - 1	Passengers - None
Injuries:	Crew - 1 (Fatal)	Passengers - None
Nature of Damage:	Minor damage to paraglider canopy	
Commander's Licence:	'Club Pilot (Novice)' - no CAA licence required	
Commander's Age:	53 years	
Commander's Flying Experience:	Approximately 100 hrs	
Information Source:	AAIB Field Investigation

Synopsis

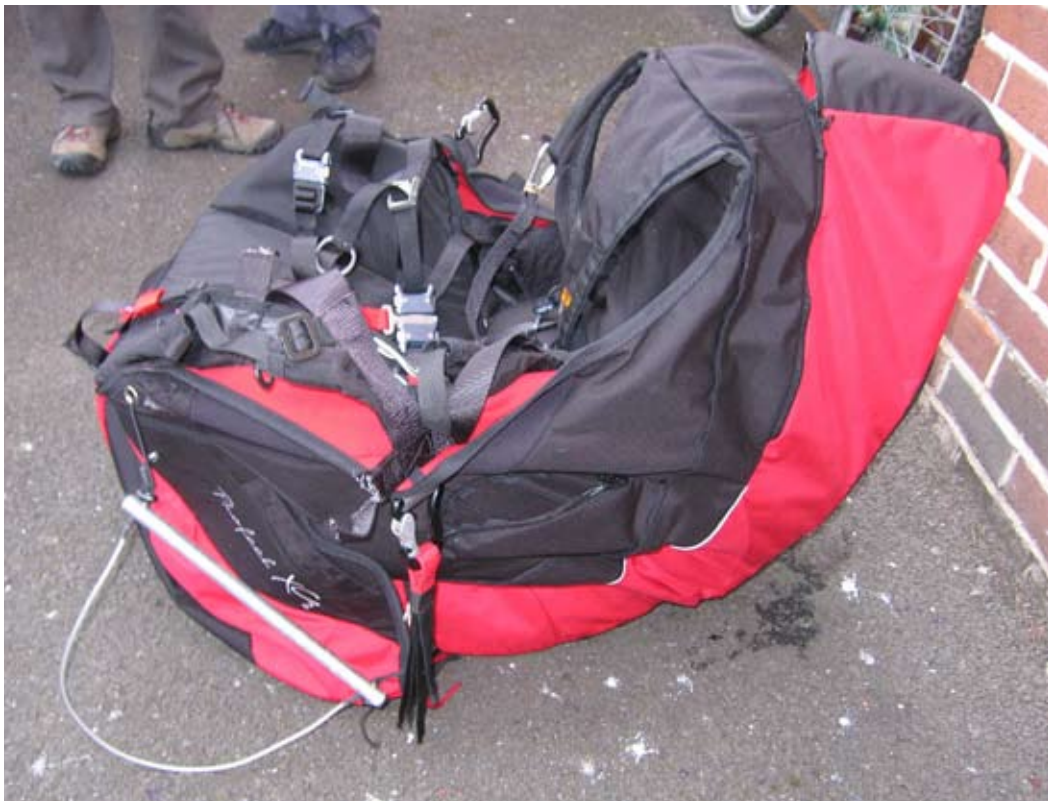
Figure 1
Profeel XC2 harness

The Profeel XC2 harness, (Figure 1), was fitted with shoulder, lap and leg straps to secure the pilot. The shoulder straps were attached to the lap straps and both the lap and leg straps were fastened using quick release latches, which could be released by simultaneously pressing two tabs on the latch. A reserve parachute was carried in a pocket on the lower right side of the harness and an additional pocket was provided on the rear of the harness to allow stowage of personal items. The harness incorporated a 'Bumpair 17' back protection system, which was designed to provide cushioning in the event of a hard landing. The 'Bumpair 17' consists of a 40-litre multi-cell shaped foam 'cushion' extending from the pilots shoulders around the base of the harness and under the pilot's thighs, reaching its maximum thickness at the base of the spine and under the pilot's thighs. The foam is designed to release air and compress at a controlled rate, to minimise shock loading of the spine and legs.

The harness showed no defects which would have contributed to the accident, or which would have prevented the pilot releasing himself from the harness whilst in the water.

The harness lap and leg straps would have made swimming difficult and would have hampered the pilot's attempts to climb onto the submerged rocks. The buoyancy from the Bumpair air bag in the harness would also have tended to push the pilot's head underwater, this being compounded by the pilot's lack of a life jacket. These facts, together with the sea state presented by the spring tide and prevailing weather, resulted in a set of circumstances that significantly increased the likelihood of drowning.

It is recommended that the British Hang Gliding and Paragliding Association (BHPA) highlights this accident to its members and reinforces the importance of using the appropriate safety equipment.
