ACCIDENT

Aircraft Type and Registration:	UP Makalu wing and Sup'air X-Alps harness	
No & Type of Engines:	None	
Year of Manufacture:	2003	
Date & Time (UTC):	26 May 2007 at 1402 hrs	
Location:	Wether Fell, Hawes, North Yorkshire	
Type of Flight:	Private	
Persons on Board:	Crew - 1	Passengers - None
Injuries:	Crew - 1 (Fatal)	Passengers - N/A
Nature of Damage:	None	
Commander's Licence:	Pilot (Hill)	
Commander's Age:	45 years	
Commander's Flying Experience:	Regular flying since 2002, actual hours unknown	
Information Source:	AAIB Field Investigation

Synopsis

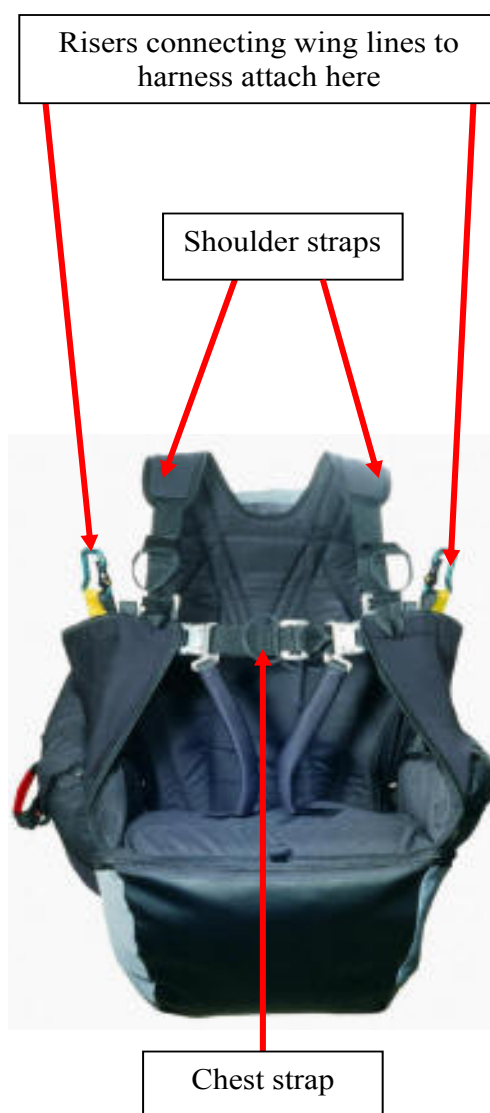
Figure 1

Typical harness layout

The chest belt performs the further function of adjusting the distance between the two risers. Correct setting of this strap is important in determining the flight characteristics of the wing. Fully tightened, it gives the sensation of more security but can make the paraglider easier to spin. Too 'open' a setting (whereby the risers are held relatively far apart) makes the wing less stable, less likely to recover automatically from a partial collapse and makes recovery from spiral dives and partial collapse less certain – no longer within the parameters of a certified glider.
