ACCIDENT

Aircraft Type:	Paramotor (comprising a 'Revolution' wing and 'PAP1400AS' paramotor unit), no registration	
No & Type of Engines:	1 'SNAP100' two-stroke piston engine	
Year of Manufacture:	Wing manufactured in 2006	
Date & Time (UTC):	11 June 2007 at 1920 hrs	
Location:	Chavenage Green Airstrip, near Tetbury, Gloucestershire	
Type of Flight:	Private	
Persons on Board:	Crew - 1	Passengers - None
Injuries:	Crew - 1 (Fatal)	Passengers - N/A
Nature of Damage:	Paramotor unit extensively damaged	
Commander's Licence:	N/A - licence not required	
Commander's Age:	24 years	
Commander's Flying Experience:	In excess of 350 hrs hours paramotor Last 90 days - Not known Last 28 days - Not known	
Information Source:	AAIB Field Investigation, with assistance from the BHPA and the BMAA

Synopsis

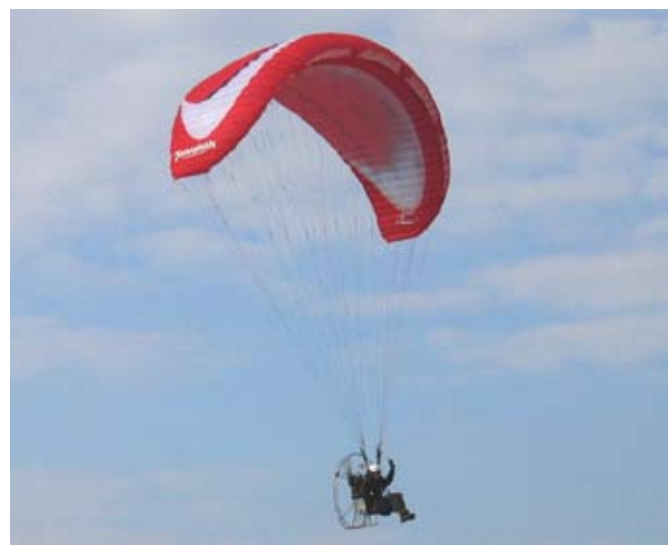
Figure 1

The aircraft was a foot-launched, powered paraglider, comprising a non-rigid fabric 'Paramania Revolution' parafoil, red and white in colour, attached to a 'PAP1400AS' paramotor unit (Figure 1). The paramotor unit is worn in a similar manner to a backpack and consists of a stainless steel metal chassis, to which are attached the engine and the pilot's seat and harness assembly. The pilot must stand to launch and land the aircraft, but may adopt a seated position in flight.

Photograph of paramotor aircraft
