ACCIDENT

Wing:	Paramania Revolution 23	
Paramotor unit:	Modified H & E Paramotores R120 series	
Year of Manufacture:	2005	
Date & Time (UTC):	8 July 2007 at 1950 hrs	
Location:	Middle Barn Farm, Bexhill, East Sussex	
Type of Flight:	Private	
Persons on Board:	Crew - 1	Passengers - None
Injuries:	Crew - 1 (Fatal)	Passengers - N/A
Nature of Damage:	Substantial	
Commander's Licence:	None required	
Commander's Age:	42 years	
Commander's Flying Experience:	5 years (paramotors)	
Information Source:	AAIB Field Investigation

Synopsis

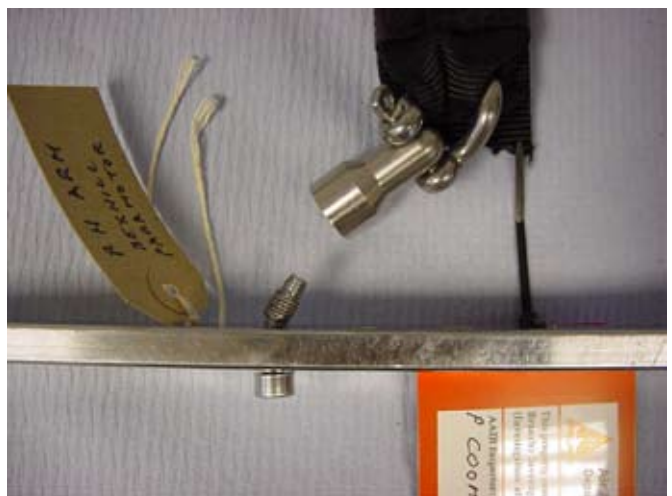
The additional fitting on the right side consisted of an internally-threaded cylindrical component, tapering to a reduced diameter cylindrical end section (Figure 4). This incorporated an eye-end through which passed a clevis pin, supporting a shackle to which the right-hand webbing was attached. The shackle was of the ‘right-angle’ type, with the portion to which the webbing was attached orientated at 90° to the shackle-pin axis. Although the shackle initially appeared to have been deformed to this condition by loading, shackles with this geometry are available from, for instance, suppliers of yacht equipment.

The fitting had been secured to the arm by means of a bolt passing through a hole in the arm and into the internally threaded section of the body of the fitting. It was attached to the body via a helical thread insert.

The right arm was not significantly damaged but the additional fitting, described above, had ‘pulled out’

Figure 4
Right lift arm, threaded connection

(Figure 4) as a result of the threaded insert failing to retain the bolt within the body of that fitting, under the influence of an axial load component. This bolt was also found to be severely bent.

Examination and sectioning of the right-hand load attachment fitting revealed that only two threads were fully engaged and a further four were only partly engaged. This would significantly reduce the failure load. In addition, a series of other variable factors would influence the strength of the attachments:

The bending of the bolt during the failure of the fitting on the right arm indicated a substantial load component at right angles to the bolt axis. This suggested a failure load range falling only slightly above the lowest range of the figures predicted for a direct lateral bolt load. Circular regions of compressive distortion of the material of the right arm surrounding the shackle holes were evident. These indicated that the bolt had been torque-tightened into the fitting on a number of occasions, whilst mounted in a number of different holes. The hole occupied by the bolt on the occasion of the failure was amongst those with significant compressive distortion. Calculations showed that a reduction of load-carrying capacity would have

In summary, the conclusion from the calculation of the failure loads was that it was probable that the failure of the bolted attachment (the right side of the paramotor unit) occurred first and load transfer to the shackle/pin attachment (the left side) followed. This sequence was further indicated by the bending directions of the failed left-hand arm, suggesting its failure load occurred after the seat and occupant had rotated about a longitudinal axis following failure of the right-hand attachment.
