ACCIDENT

Wing:	Paramania Revolution 23	
Paramotor unit:	Modified H & E Paramotores R120 series	
Year of Manufacture:	2005	
Date & Time (UTC):	8 July 2007 at 1950 hrs	
Location:	Middle Barn Farm, Bexhill, East Sussex	
Type of Flight:	Private	
Persons on Board:	Crew - 1	Passengers - None
Injuries:	Crew - 1 (Fatal)	Passengers - N/A
Nature of Damage:	Substantial	
Commander's Licence:	None required	
Commander's Age:	42 years	
Commander's Flying Experience:	5 years (paramotors)	
Information Source:	AAIB Field Investigation

AAIB Special Bulletin 4/07

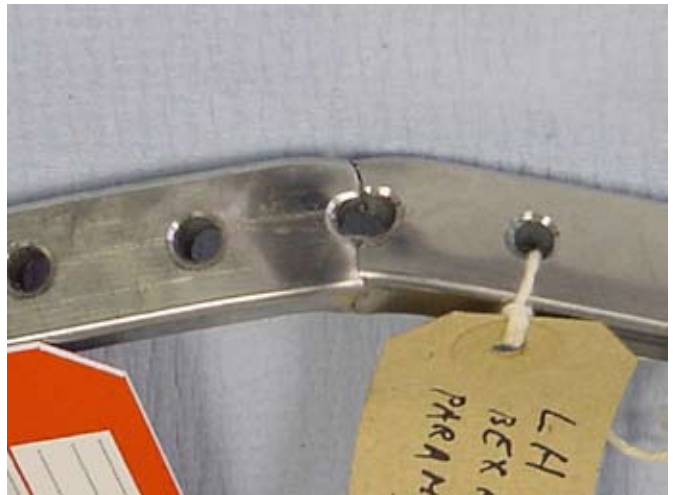
Figure 3

Left lift arm, outboard surface

The left arm had suffered a complex failure where the shackle-pin passed through the hole in the arm

(Figures 2 and 3). This appeared to be a bending failure in two axes allowing the clevis pin to break out of the hole but, after the failure, some remaining material in the box section surrounding the hole had allowed the forward end of the failed arm to remain united with the hinged end of the arm.

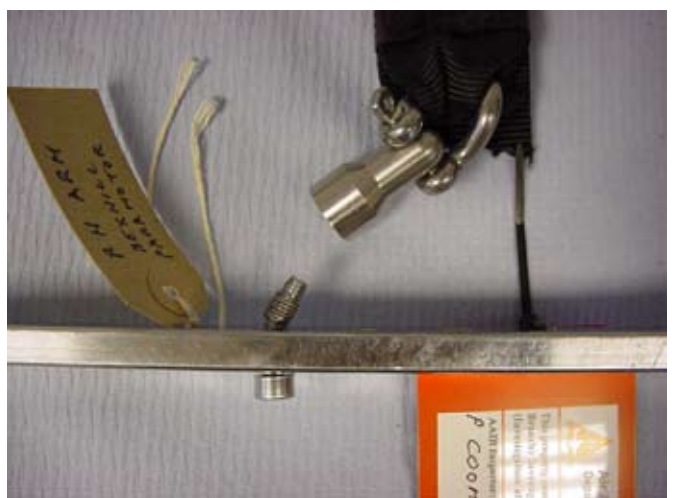
Figure 4

The additional fitting on the right side consisted of an internally-threaded cylindrical component, tapering to a reduced diameter cylindrical end section (Figure 4). This incorporated an eye-end through which passed a clevis pin, supporting a shackle to which the right-hand webbing was attached. The shackle was of the ‘right-angle’ type, with the portion to which the webbing was attached orientated at 90° to the shackle-pin axis. Although the shackle initially appeared to have been deformed to this condition by loading, shackles with this geometry are available from, for instance, suppliers of yacht equipment.

The fitting had been secured to the arm by means of a bolt passing through a hole in the arm and into the internally threaded section of the body of the fitting. It was attached to the body via a helical thread insert.

The right arm was not significantly damaged but the additional fitting, described above, had ‘pulled out’

Right lift arm, threaded connection

(Figure 4) as a result of the threaded insert failing to retain the bolt within the body of that fitting, under the influence of an axial load component. This bolt was also found to be severely bent.

Examination and sectioning of the right-hand load attachment fitting revealed that only two threads were fully engaged and a further four were only partly engaged. This would significantly reduce the failure load. In addition, a series of other variable factors would influence the strength of the attachments:

The bending of the bolt during the failure of the fitting on the right arm indicated a substantial load component at right angles to the bolt axis. This suggested a failure load range falling only slightly above the lowest range of the figures predicted for a direct lateral bolt load. Circular regions of compressive distortion of the material of the right arm surrounding the shackle holes were evident. These indicated that the bolt had been torque-tightened into the fitting on a number of occasions, whilst mounted in a number of different holes. The hole occupied by the bolt on the occasion of the failure was amongst those with significant compressive distortion. Calculations showed that a reduction of load-carrying capacity would have

In summary, the conclusion from the calculation of the failure loads was that it was probable that the failure of the bolted attachment (the right side of the paramotor unit) occurred first and load transfer to the shackle/pin attachment (the left side) followed. This sequence was further indicated by the bending directions of the failed left-hand arm, suggesting its failure load occurred after the seat and occupant had rotated about a longitudinal axis following failure of the right-hand attachment.
