REPORT

**Investigation of a paragliding accident
which occurred at the Eagle's Nest, Mirhleft, Morocco,
on 5th November 2009
in which the pilot suffered fatal injury.**

BHPA investigation serial number: IR 09/098

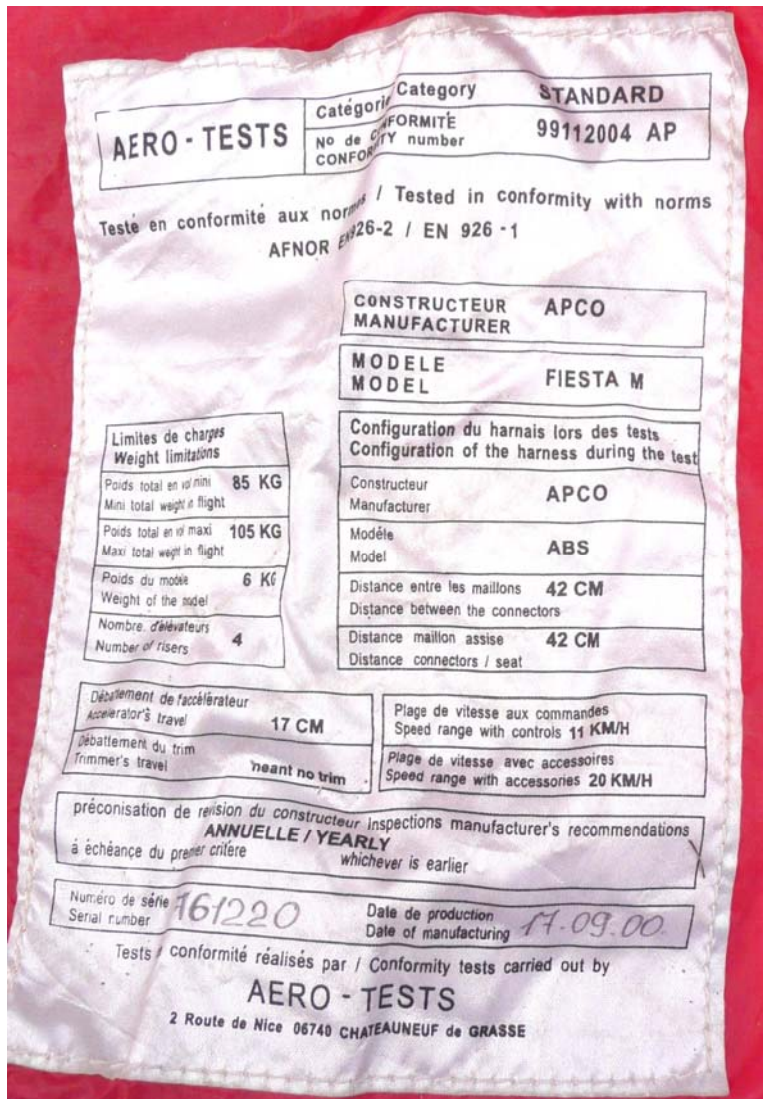
Chest strap setting: 52 cm between riser centres.

Harness chest strap setting (Distance between risers).

A paraglider’s stability (i.e. its tendency to remain undisturbed by turbulence) and its recovery characteristics (its ability to recover to normal flight after an upset) are both significantly affected by the geometry of the pilot’s harness. The most critical part of the harness geometry is the distance between the main riser karabiners – which is set by the pilot by adjusting the ‘chest strap’. When paragliders are certified, the test pilot sets his harness at the appropriate setting: 38cms for small gliders (<50kg pilot weight), 42cms for medium gliders and 46cms for large gliders (>80kg pilot weight). All the flight tests are carried out at this setting. The glider involved in this accident had a take-off weight range of 85kg to 105kg and had a correctly affixed placard showing the certification details which includes the harness settings used during certification: these are recorded as being 42cms between the connectors - and at this setting the type was certified at the EN ‘Standard’ level. (The levels on this certification scheme went from ‘Standard’ (most stable) to ‘Competition’ (least stable)). The accident pilot had set his harness so that the actual distance between connectors was 52cms. With the harness set up in this way the glider’s stability and recovery characteristics would be worse than those established at the certified setting.
