**Investigation of a paragliding accident
which occurred at the Eagle's Nest, Mirhleft, Morocco,
on 5th November 2009
in which the pilot suffered fatal injury.**

BHPA investigation serial number: IR 09/098

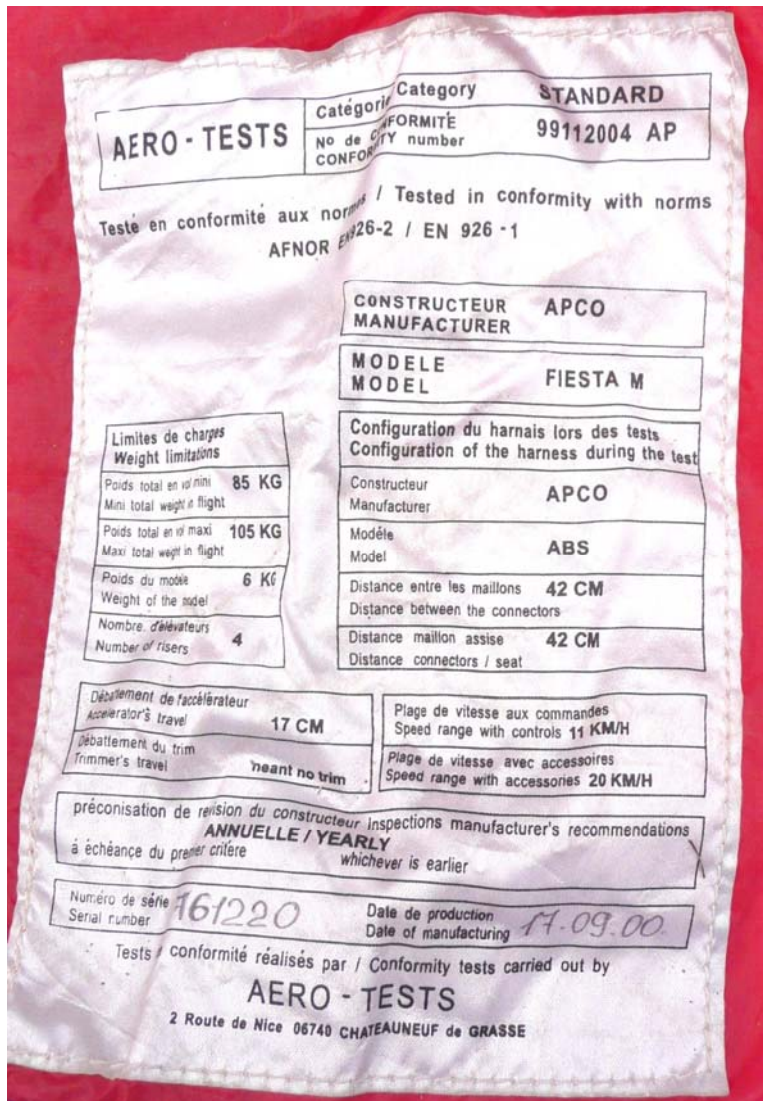
Harness chest strap setting (Distance between risers).

A paraglider’s stability (i.e. its tendency to remain undisturbed by turbulence) and its recovery characteristics (its ability to recover to normal flight after an upset) are both significantly affected by the geometry of the pilot’s harness. The most critical part of the harness geometry is the distance between the main riser karabiners – which is set by the pilot by adjusting the ‘chest strap’. When paragliders are certified, the test pilot sets his harness at the appropriate setting: 38cms for small gliders (<50kg pilot weight), 42cms for medium gliders and 46cms for large gliders (>80kg pilot weight). All the flight tests are carried out at this setting. The glider involved in this accident had a take-off weight range of 85kg to 105kg and had a correctly affixed placard showing the certification details which includes the harness settings used during certification: these are recorded as being 42cms between the connectors - and at this setting the type was certified at the EN ‘Standard’ level. (The levels on this certification scheme went from ‘Standard’ (most stable) to ‘Competition’ (least stable)). The accident pilot had set his harness so that the actual distance between connectors was 52cms. With the harness set up in this way the glider’s stability and recovery characteristics would be worse than those established at the certified setting.
