# REPORT

**Investigation of a hang gliding accident  
which occurred at Clatter, Mid Wales,  
on 27<sup>th</sup> June 2010  
in which one pilot suffered serious injury.**

**BHPA investigation serial number: IR 10/060**

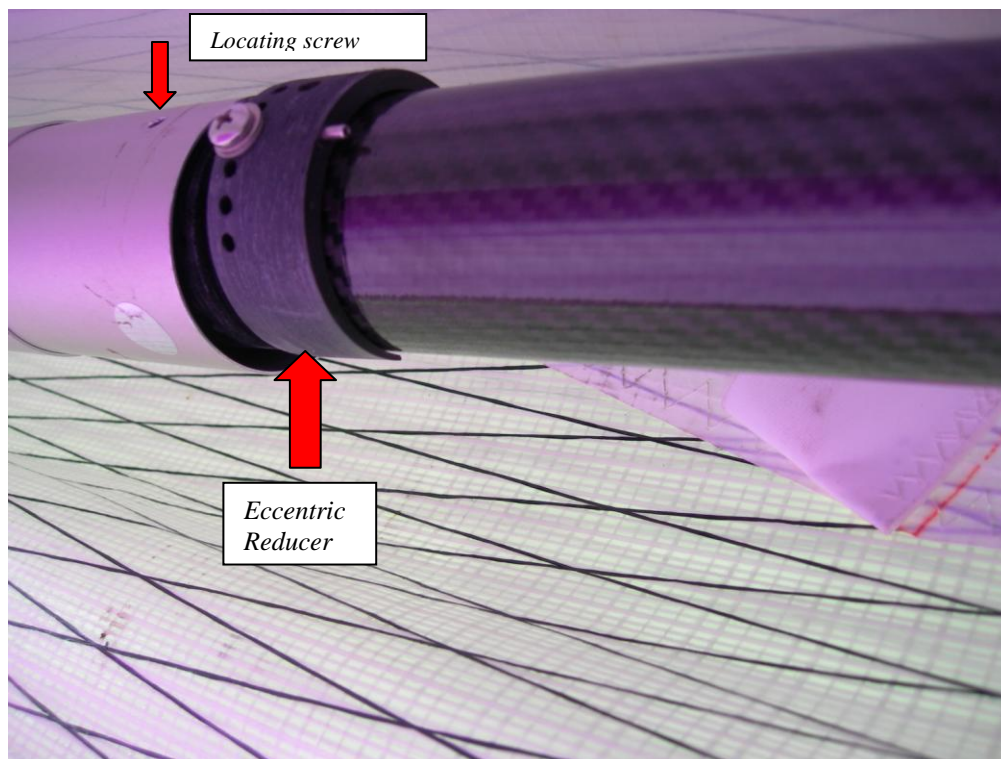
*Right Leading Edge*

Examination of the wreckage of Pilot B's hang glider revealed that the eccentric reducer rings on both leading edges were out of position. The outboard c/f leading edges are located within the inner aluminium leading edges with a clevis pin near the inboard end of the c/f tube and an eccentric reducer ring at the end of the aluminium tube. The eccentric reducer rings should be located with a self tapping screw through a

hole in the inner leading edge. On both leading edges the eccentric reducer ring (with the self tapping screw attached) was loose and had slid along the leading edge toward the tip. The screw holes were intact, so clearly these rings had not pulled out.

The glider manufacturer has commented that he believes that the glider would be flyable with these rings out of position, but possibly with a reduced roll rate.

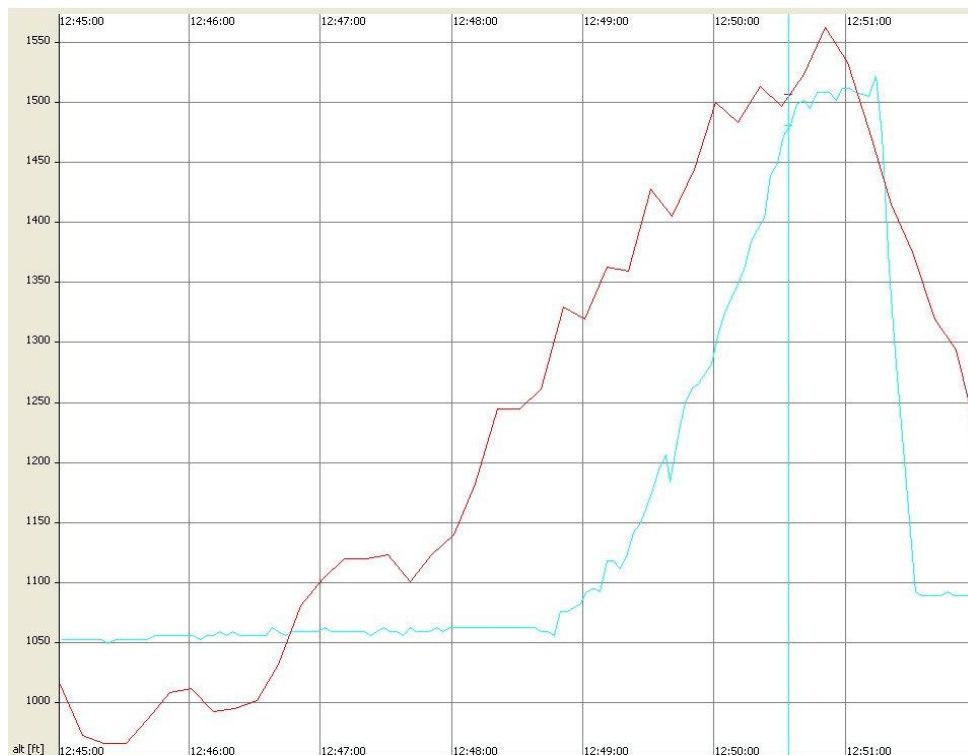
Pilot B did not see Pilot A during the five climbing circles of his climb. This may have been due to the fact that Pilot A was higher than him and it is possible that Pilot A was masked by his wing. Pilot B's average climb rate was approximately 1.5m/s (300fpm) so it is unlikely that extreme bank angles were being used.

Barograph traces for the two pilots. Red trace = Pilot A, Blue trace = Pilot B

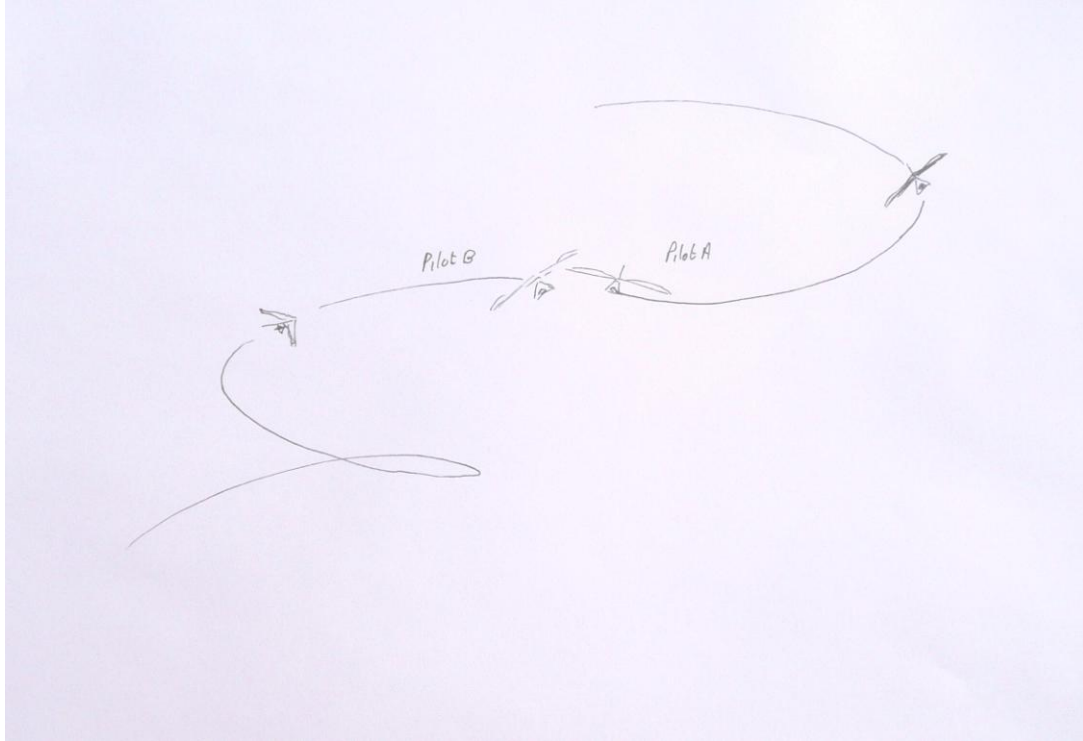
Pilot A did have Pilot B in view during much of the sequence, but adjudged that he was at a safe distance. Pilot A then seems to have been caught out by their rapidly changing positions and heights. Pilot A was in weaker lift fractionally downwind of the core of the thermal – whilst Pilot B was in stronger lift in the core. At 12:50 Pilot A was 200 feet higher than Pilot B. Thirty seconds later they collided. During some of the 180 degrees of turn before the collision, Pilot A's wing would have masked his view of Pilot B. And they would have had a closing speed of approximately 60mph.

*Probable glider paths*

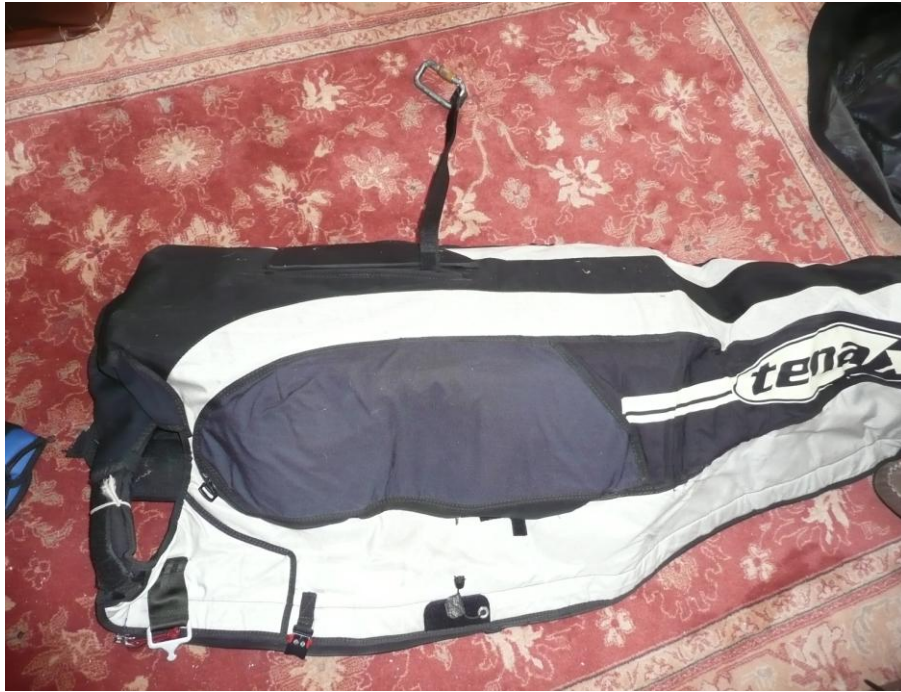
The BHPA parachute system target descent rate of between 5 – 6m/s is based on the pilot impacting the ground upright. In this accident the pilot impacted head first. The Tenax harness has a single suspension strop which connects to a slider on the harness back plate.

*Pilot B's single suspension strop harness*

The parachute bridle was connected to the main karabiner at the top of this suspension strop. In normal use the pilot adjusts his body position by pushing or pulling his upper body up or down by reacting on the base bar/uprights, and the slider moves until the pilot is balanced. In this accident the parachute deployed behind the pilot, which resulted in the slider being pulled to the maximum rearward position. With the pilot's cg ahead of the suspension point, the pilot was rotated into a fully head-down position. Also as the glider became supported by the parachute, the glider swung down into a nose-down position. Despite the pilot's considerable efforts, he was unable to alter his head-down position.

2. No emergency parachute system should suspend the pilot head downward. It is recommended that the BHPA FSC should consider what steps should be taken to reduce the likelihood of this occurring again.

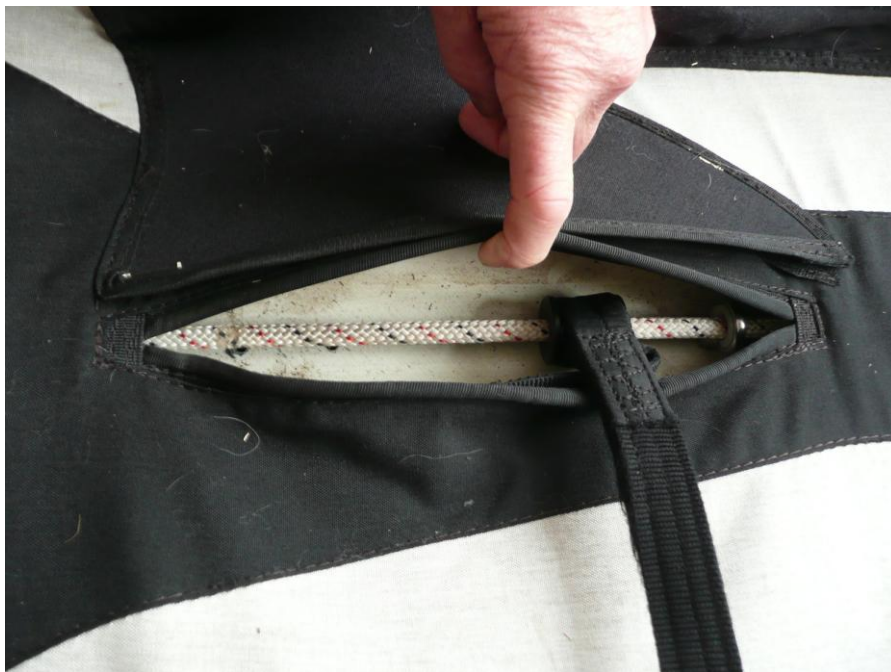
*Slider system in back of harness.*

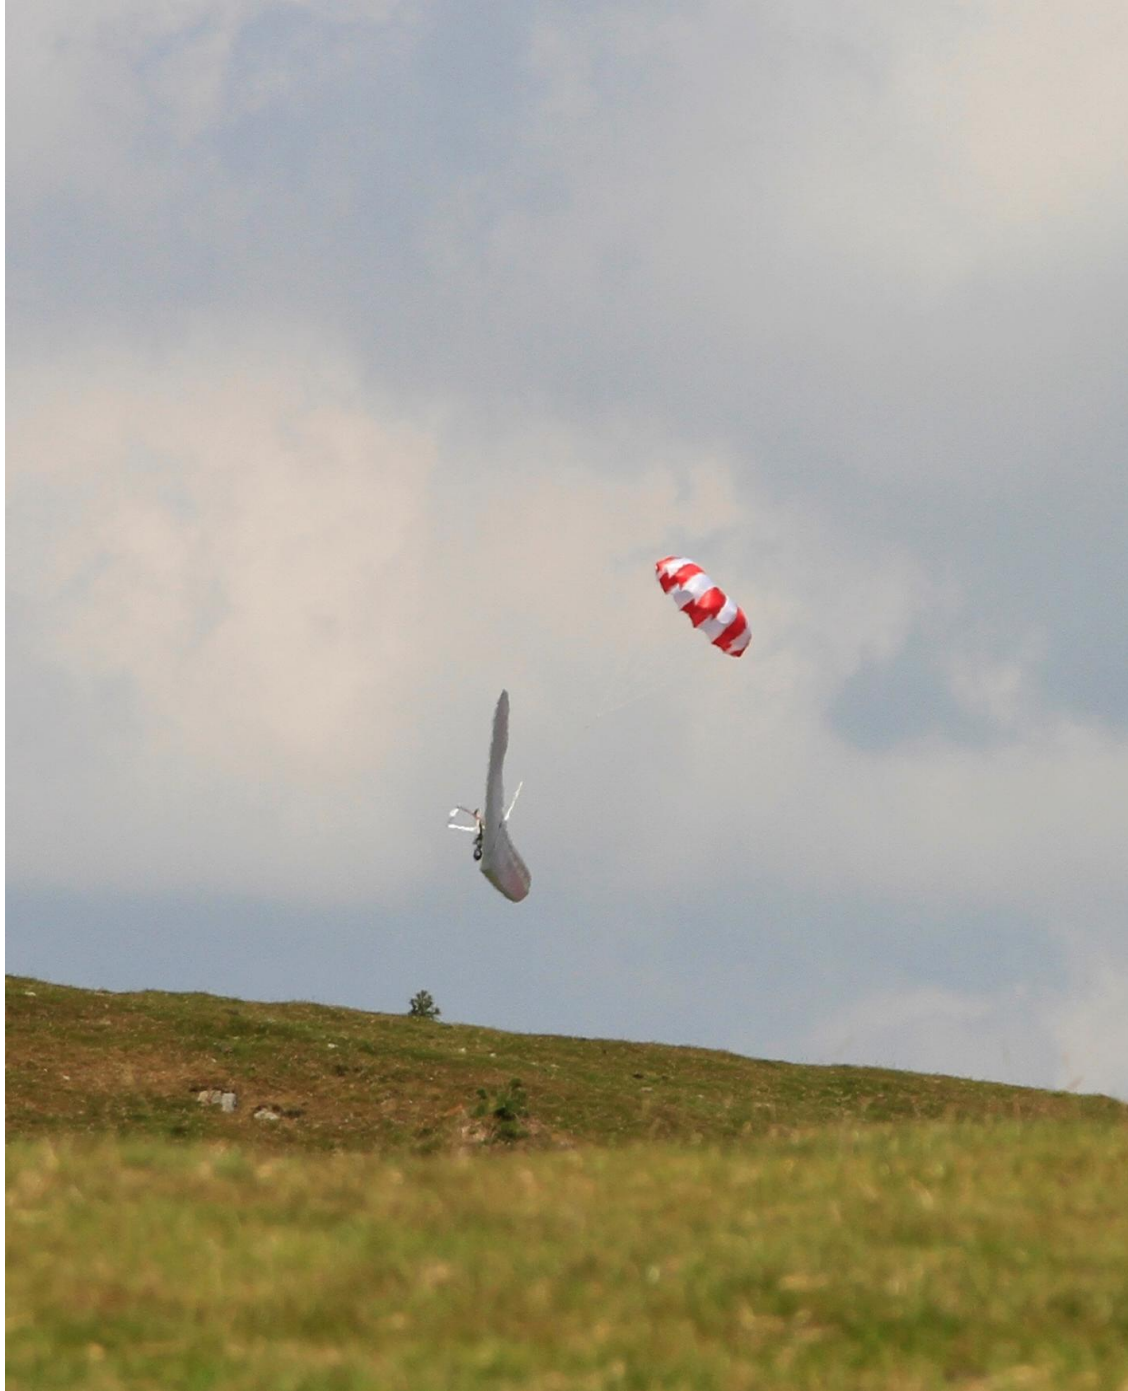
Pilot B descended under his emergency parachute at a velocity of approximately 9.0m/s, as recorded by his instruments. The pilot was suspended by his harness in a head down position – and impacted in this position. Pilot B sustained very serious injury in the impact.

*Pilot B an instant before impact.*
