British Hang Gliding and Paragliding Association

REPORT

**Investigation of a paragliding accident
which occurred at Newgale beach, Pembrokeshire,
on Sunday 28th August 2011
in which the pilot suffered fatal injury.**

BHPA investigation serial number: IR 11/070

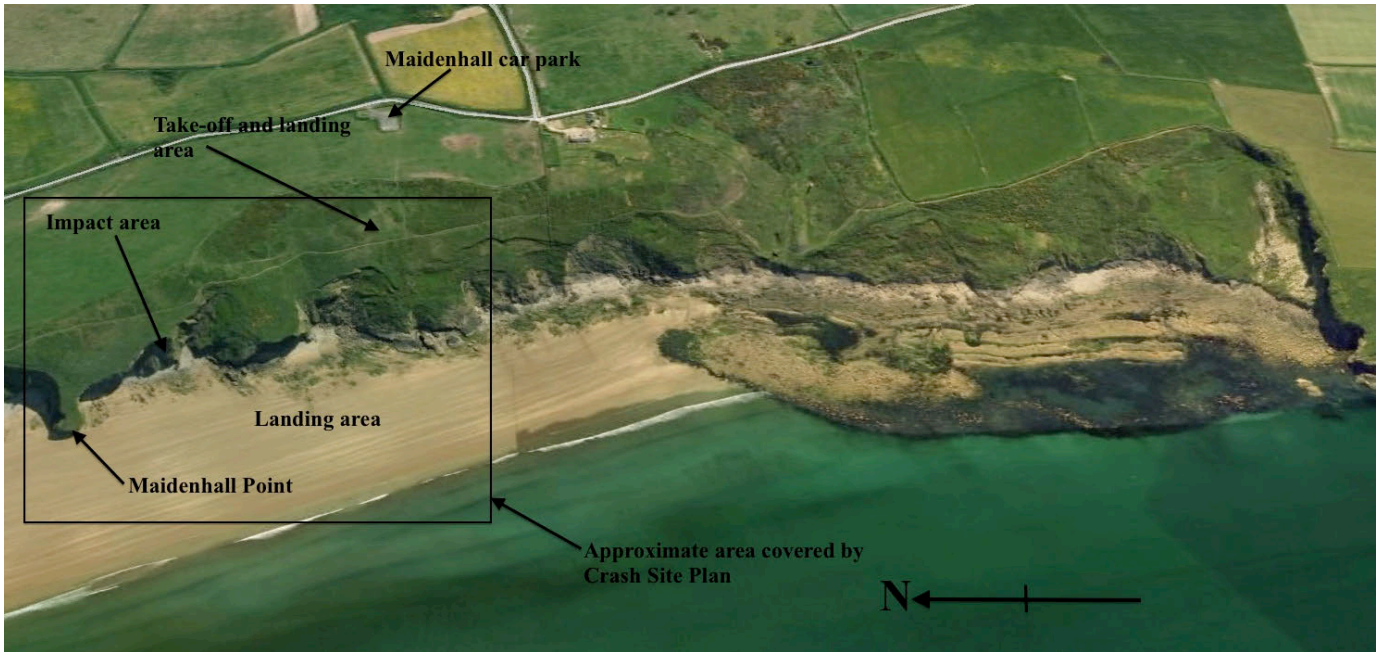
Site Plan

Newgale beach occupies the northern half of St Brides Bay in Pembrokeshire. The area used for paragliding is located at the southern end of the beach where the cliffs extend for approximately one mile to the south, and range in height from 15 – 70 metres (see site plan below).

The take-off area is situated on the sloping, grassy area just northwest of the Maidenhall car park. Landing is at the same area or on the beach. The cliffs are generally west facing, though they are undulating with many bowls and gullies. In these undulating areas the cliff can be facing anything from northwest round to southwest.

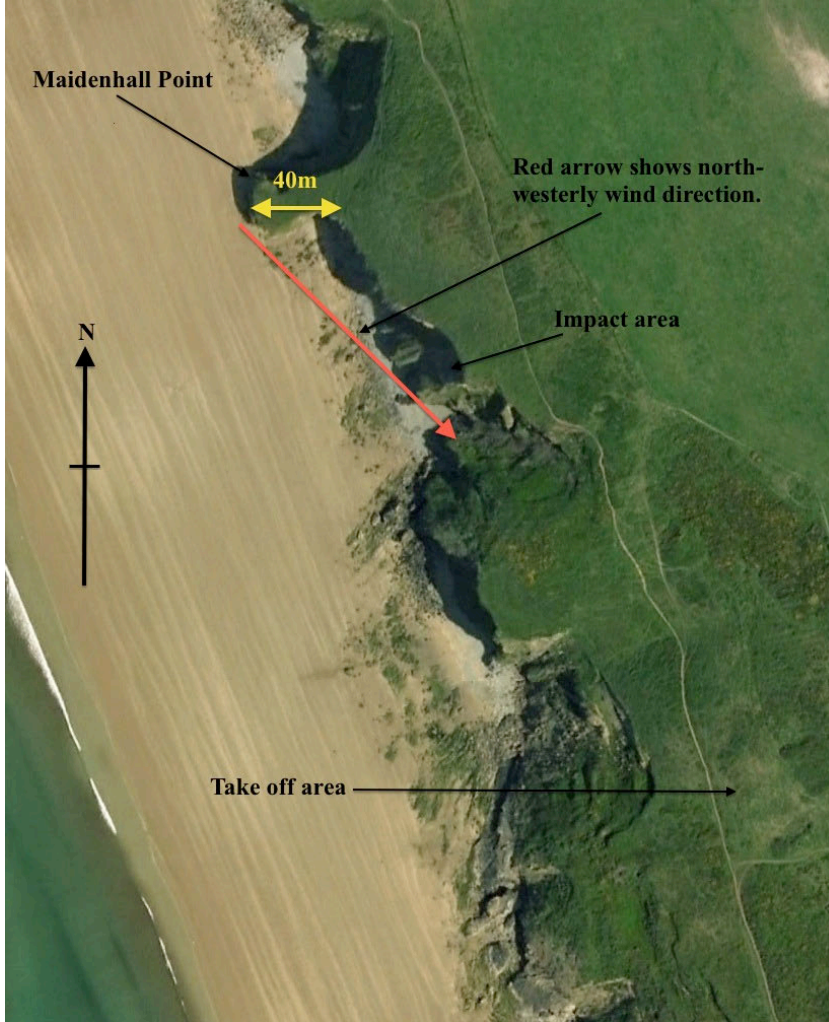
Crash Site Plan

The area where the incident occurred lies approximately 100 metres southeast of an outcrop known as Maidenhall Point (see Site Plan below). In this area the cliffs are approximately 30 metres high and face southwest. The cliffs here are steep and have rocks at the base.
