REPORT

Investigation of a powered paraglider incident which occurred at Pilling, Lancs., on 23rd October 2016 in which the pilot suffered fatal injury.

BHPA investigation serial number: IR GBR-2017-4356

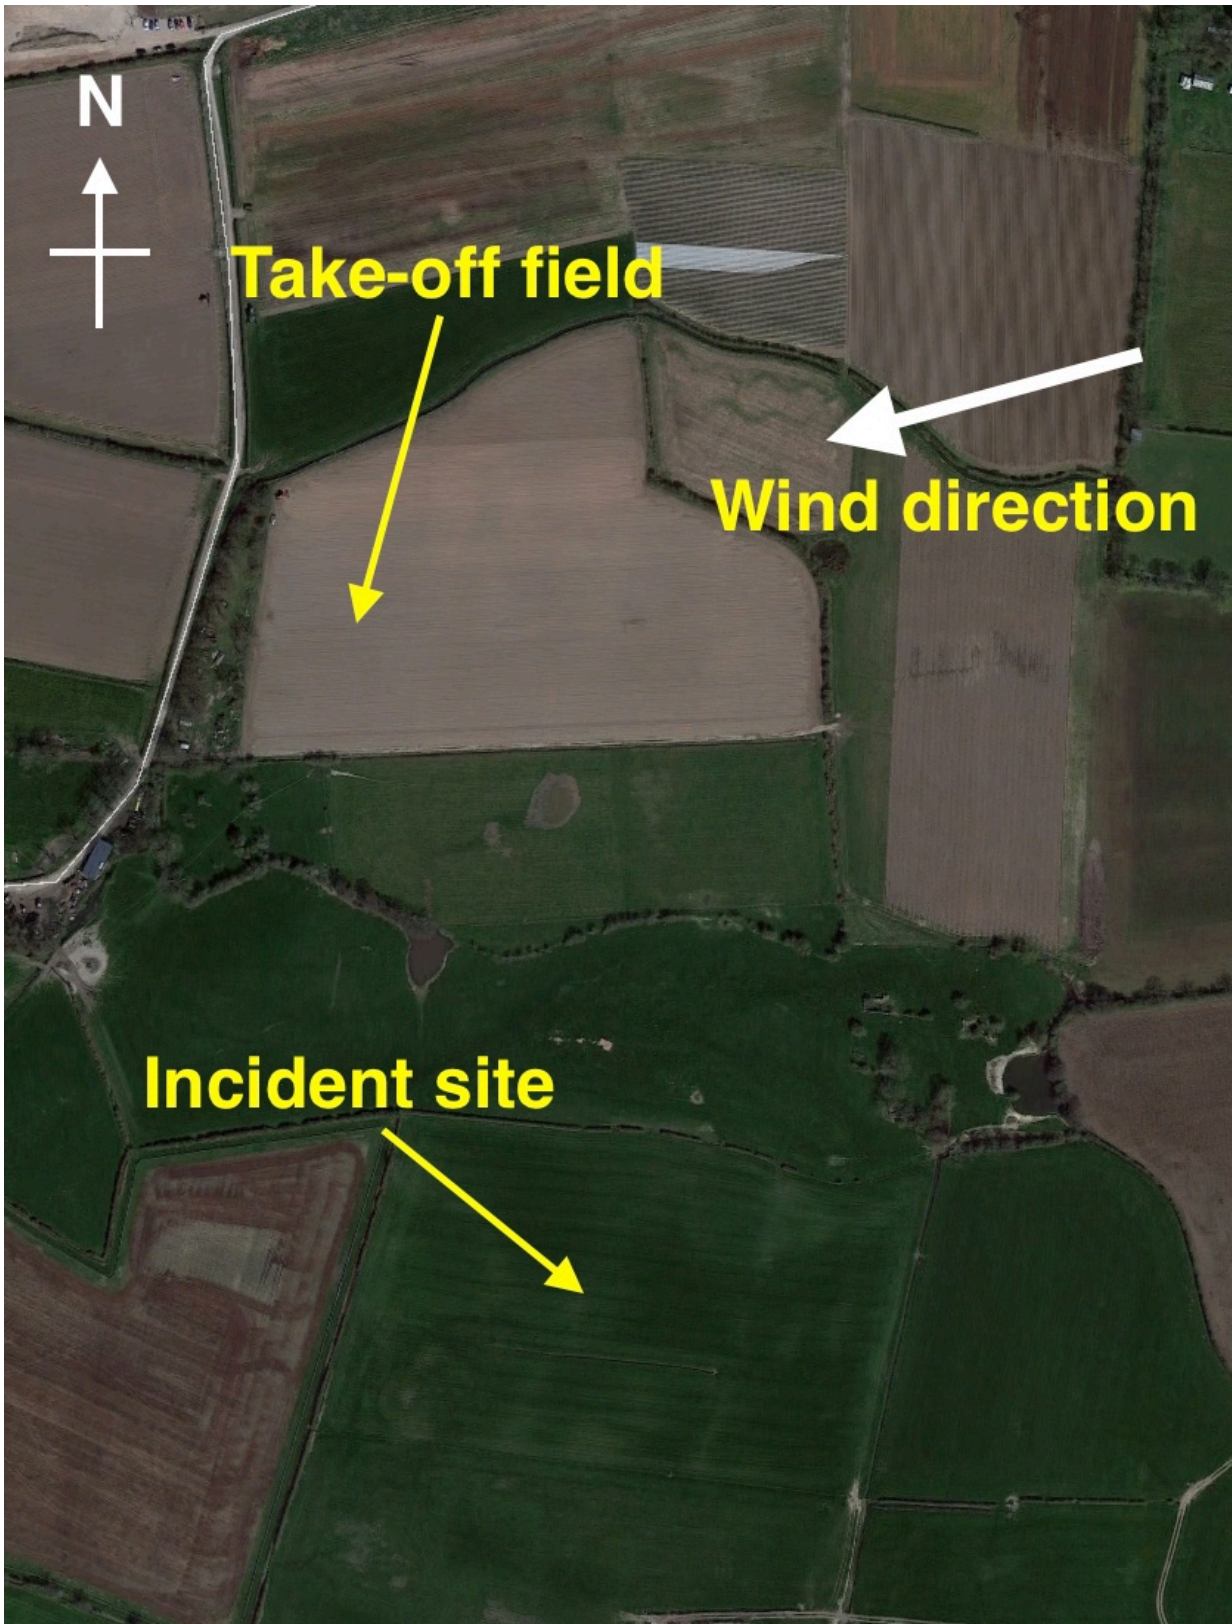
Figure 1.

The incident occurred over a large field approximately 300m south of the take-off field. With the prevailing wind in an easterly direction there were no obvious sources of mechanical turbulence. Figure 1 below shows the take-off field and the incident site.
