# SAFETY ADVISORY

Issued by Angus Pinkerton - Chairman of the Flying & Safety Committee 21 April, 2015.

## Speed systems and risers.

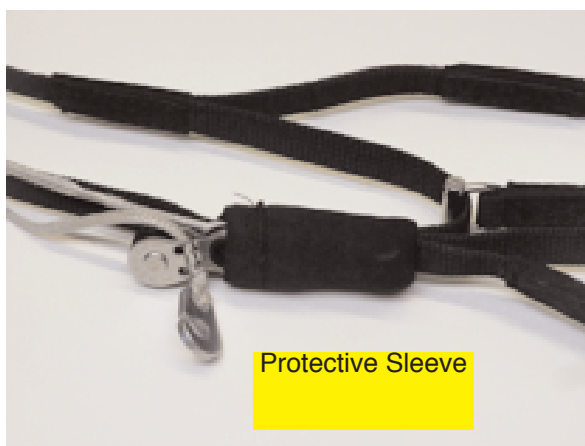
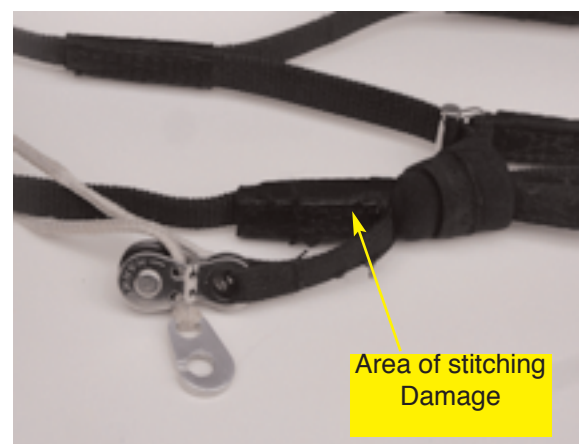
The BHPA have had reports of two cases where the speed system has failed in flight. Both gliders (A Gin Carrera and a U-Turn Lightning) have suffered from one of the speed system pulleys coming away from the riser. The integrity of the riser itself is not affected.

Like many other models, both these wings use “skinny” risers which means there is a relatively small area of stitching where the speed system pulleys are attached. This area is put under considerable stress when the speed bar is applied and requires regular checking.

A contributory factor is that the pulleys and stitching on many gliders is concealed beneath a neoprene sheath or cover. Both Gin and U-turn have taken steps to reinforce this area, but it is very likely that other models may also be liable to similar stresses and the BHPA strongly recommend that all pilots inspect their speed systems regularly; including peeling back any protective covers, carefully inspecting the stitching and checking the webbing tabs for wear.
