SAFETY ADVISORY

Issued by Angus Pinkerton - Chairman of the Flying & Safety Committee 21 April, 2015.

Speed systems and risers.

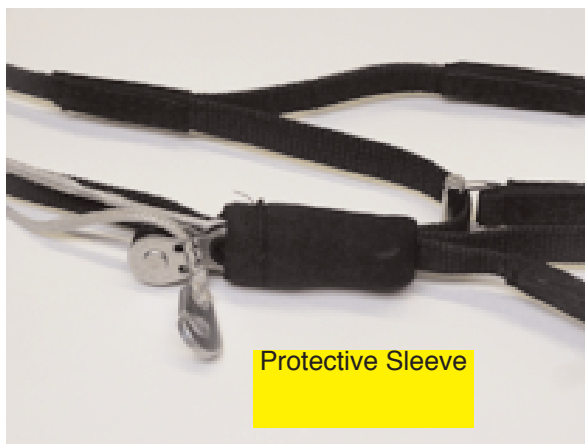
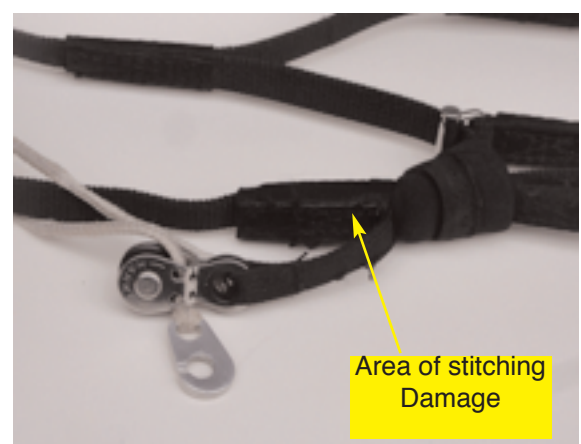
The BHPA have had reports of two cases where the speed system has failed in flight. Both gliders (A Gin Carrera and a U-Turn Lightning) have suffered from one of the speed system pulleys coming away from the riser. The integrity of the riser itself is not affected.

Like many other models, both these wings use “skinny” risers which means there is a relatively small area of stitching where the speed system pulleys are attached. This area is put under considerable stress when the speed bar is applied and requires regular checking.

A contributory factor is that the pulleys and stitching on many gliders is concealed beneath a neoprene sheath or cover. Both Gin and U-turn have taken steps to reinforce this area, but it is very likely that other models may also be liable to similar stresses and the BHPA strongly recommend that all pilots inspect their speed systems regularly; including peeling back any protective covers, carefully inspecting the stitching and checking the webbing tabs for wear.
