BHPA Incident Report: GBR-2021-20230

INCIDENT

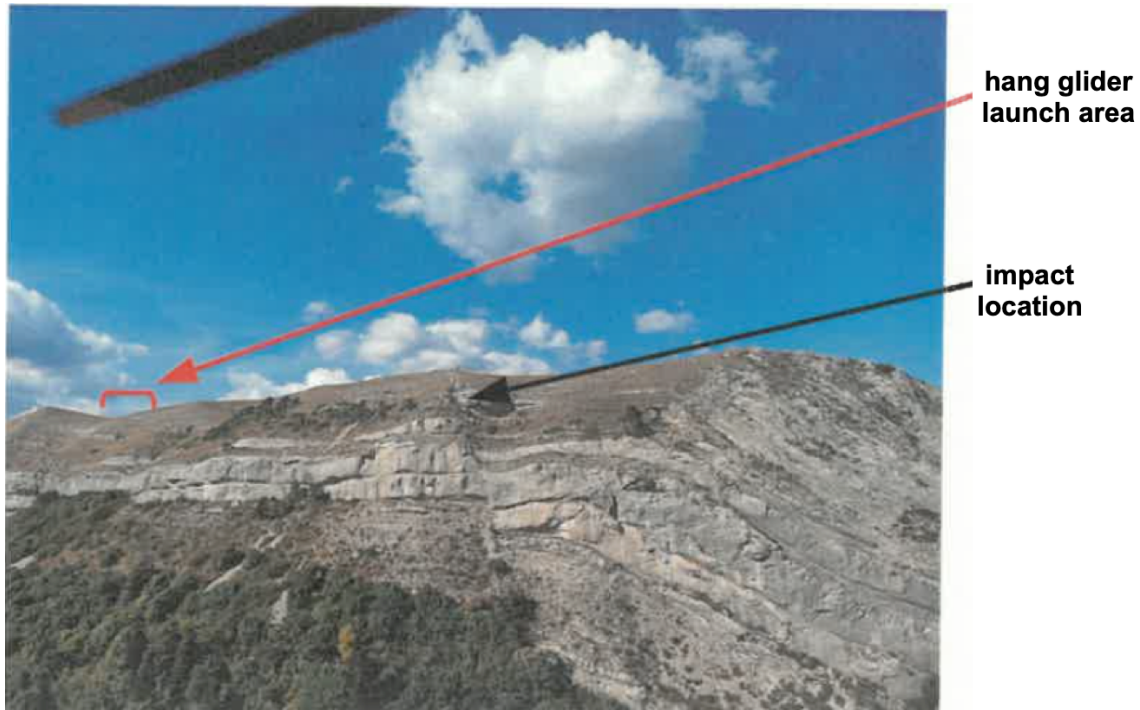
3.3.1 Aspres La Longeagne (Pré des Nonnes) is a crescent shaped mountain ridge to the northwest of the village of Aspres-sur-Buëch (see Fig. 1). Its maximum altitude is approximately 5100ft. The southern slopes are steep and forested. The ground drops away more gently to the north. The incident site is just below the ridge-top, on a steep south-southwesterly facing section of the slope, with rocks and low scrub vegetation, but bare of trees. Below this is a near vertical rockface (described by the emergency services as being approximately 30m high). At the foot of this rockface is a sloping forested area, which descends to the valley bottom. The area is shown in more detail on Fig. 2.

The ridge is a well-known hang gliding and paragliding site. The launch area (used by hang gliders on the incident day) is identified on Fig. 2. The French Freeflying Association⁴ notes that southeasterly to southwesterly winds are favourable, and that during spring and summer (between the hours of 14:00 and 16:00) conditions that may be strong, making take-off difficult at the hillside.

Fig 2. The incident location and flying area. Photograph taken from the emergency services helicopter (image extracted from the French Preliminary Investigation report).
