**ACCIDENT**

<b>Aircraft Type and Registration:</b>	UP Makalu wing and Sup'air X-Alps harness	
<b>No &amp; Type of Engines:</b>	None	
<b>Year of Manufacture:</b>	2003	
<b>Date &amp; Time (UTC):</b>	26 May 2007 at 1402 hrs	
<b>Location:</b>	Wether Fell, Hawes, North Yorkshire	
<b>Type of Flight:</b>	Private	
<b>Persons on Board:</b>	Crew - 1	Passengers - None
<b>Injuries:</b>	Crew - 1 (Fatal)	Passengers - N/A
<b>Nature of Damage:</b>	None	
<b>Commander's Licence:</b>	Pilot (Hill)	
<b>Commander's Age:</b>	45 years	
<b>Commander's Flying Experience:</b>	Regular flying since 2002, actual hours unknown	
<b>Information Source:</b>	AAIB Field Investigation

**Synopsis**

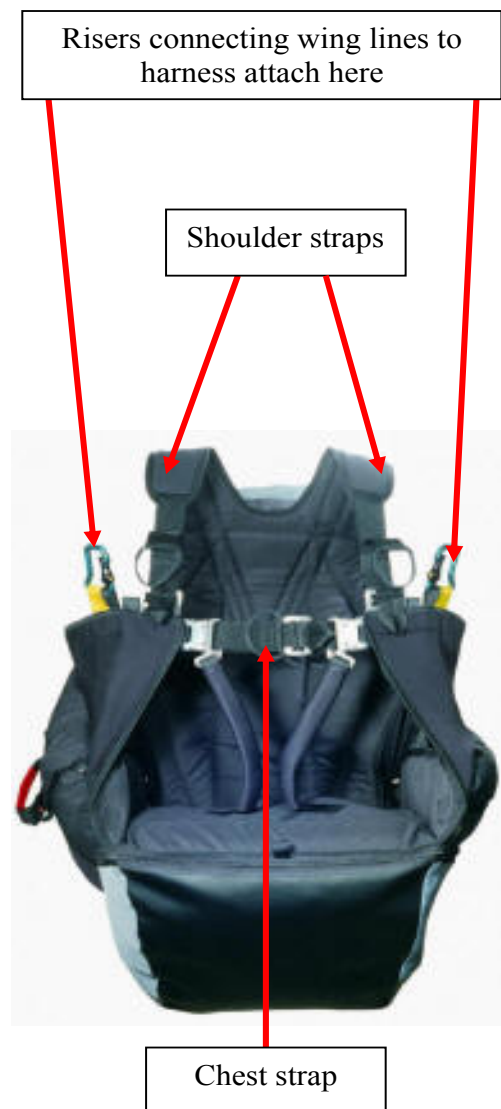
**Figure 1**

The harness was a Sup'air X-Alps Large which incorporated under the seat protection against vertical impact but no protection from side impacts. When worn on the ground and not under flight loads the harness of a paraglider is suspended from the pilots shoulders by padded straps. In the air the pilot is also secured within the harness by leg straps and a chest strap.

Typical harness layout

The chest belt performs the further function of adjusting the distance between the two risers. Correct setting of this strap is important in determining the flight characteristics of the wing. Fully tightened, it gives the sensation of more security but can make the paraglider easier to spin. Too 'open' a setting (whereby the risers are held relatively far apart) makes the wing less stable, less likely to recover automatically from a partial collapse and makes recovery from spiral dives and partial collapse less certain – no longer within the parameters of a certified glider.

The wing and harness were found to be serviceable, unmodified and in a condition commensurate with their age. It was not possible to determine the harness chest strap setting used during the accident flight, because it had probably been loosened during efforts to assist the pilot.

The BHPA commented that these characteristics can only be guaranteed if the pilot flies with the harness chest strap set correctly.
