# Batten retaining clip

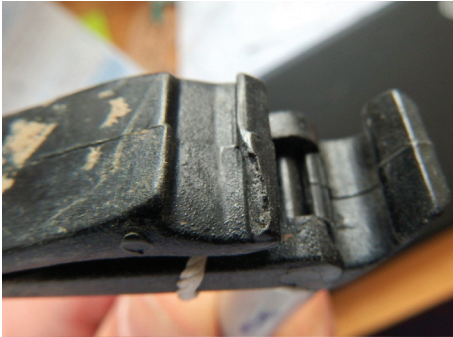
inspecting their own batten clips. Many of these used on imported gliders are to very similar designs. Some pilots have discovered hitherto-unnoticed damage (see photo at left) to these clips allowing them to open under very light loads. All hang glider pilots owning or flying gliders with these clips are encouraged to check them very carefully and replace any that are damaged. The consequences of these opening in flight are uncertain and could be very dramatic.
