Gin Gliders Safety Notice: G-Lite Rescue Parachute

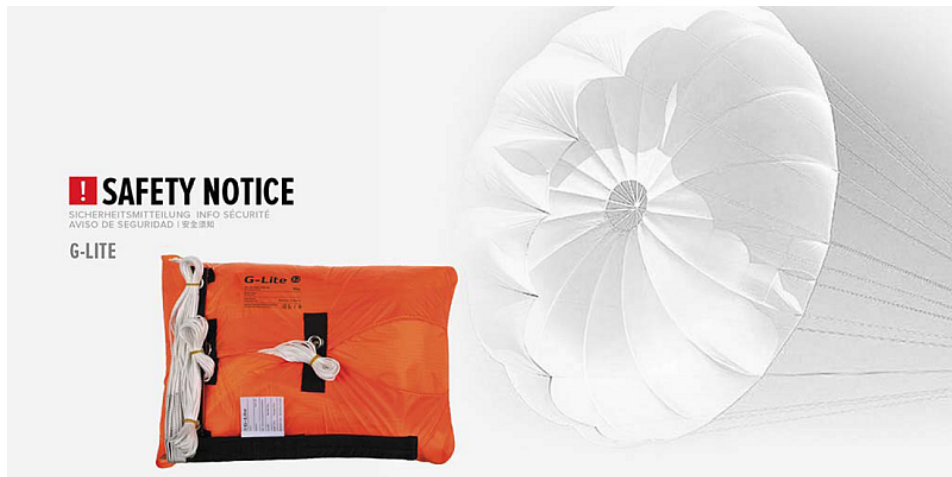
G-Lite deployment bag (G-Lite 32 and 39)

Routine inspection and testing have revealed that material degradation and/or damage may result in the breaking of the rubber bands that close the inner bag of the G-Lite rescue parachute, and thus a failed deployment.

Pilots flying with the G-lite should replace the rubber bands on their deployment bags with textile cord (shock cord) before their next flight.

Gin will provide free replacement rubber band packs for all G-Lite deployment bags; contact the dealer from whom you bought your reserve. Instructions in the link apply only to the G-Lite – other Gin rescues and inner bags are not affected.
